GRENLOCH LAKE DAM

NJ 00402

**PHASE 1 INSPECTION REPORT
NATIONAL DAM SAFETY PROGRAM**

79 04 16 087
March, 1979

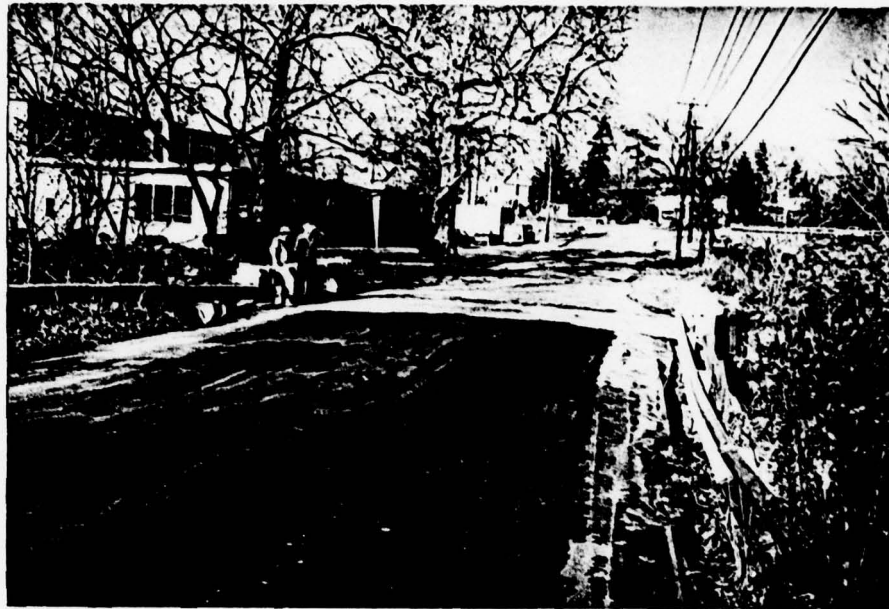
The roadway embankment, which forms the main dam structure, was assessed to be in a solid and stable condition although pavement run-off at the gutter lines causes a continual drainage problem, especially on the downstream side. The crest of the dam is an asphalt-paved two-lane street. A corrugated metal curb inlet has recently been installed just to the left of the bridge (to alleviate the run-off problem) but a considerable portion of the downstream sideslopes adjacent to the wingwalls has been washed out. There are numerous fair sized trees growing in the vicinity of the downstream wingwalls and considerable siltation was noted in the reservoir immediately upstream from the dam. The effective embankment height on both sides of the spillway bridge is extremely low as the properties on each side immediately downstream contain factory buildings and have backfilled up to within about three feet of dam crest on the left side (the H.G. Enderlein foundry) and practically at dam crest on the right (the A.C. Hyde Co.). The roadway profile is fairly level across the dam but rises on either end just past the abutments. There was no riprap protection observed at this site.

View East along crest (Central Ave.)

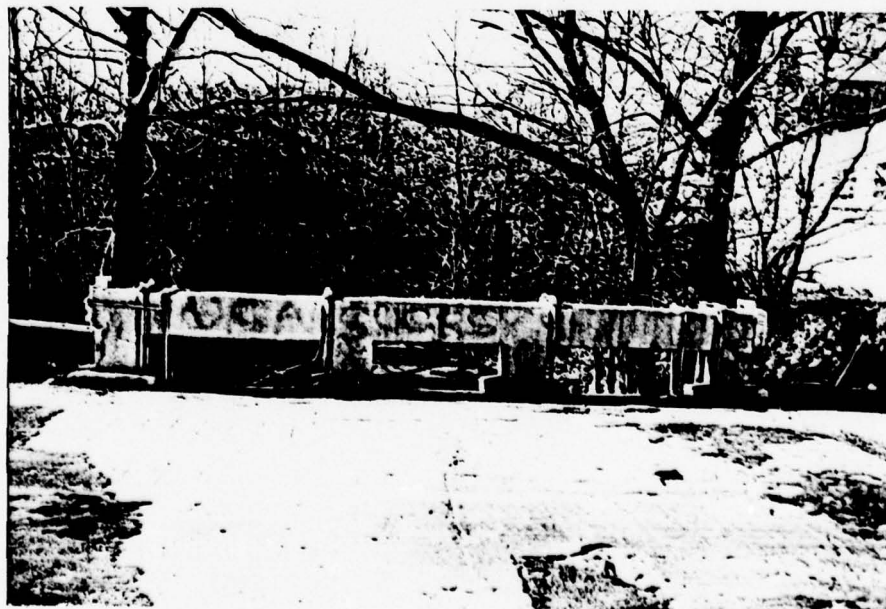
VISUAL EXAMINATION OF	OBSERVATIONS	REMARKS OR RECOMMENDATIONS
SURFACE CRACKS CONCRETE SURFACES		
STRUCTURAL CRACKING	Very old structure with much cracking and spalling.	
VERTICAL AND HORIZONTAL ALIGNMENT	Satisfactory - dam is roadway embankment.	
MONOLITH JOINTS	Satisfactory	
CONSTRUCTION JOINTS	Railing is bolted and strapped to bridge superstructure.

Bridge deck and rail

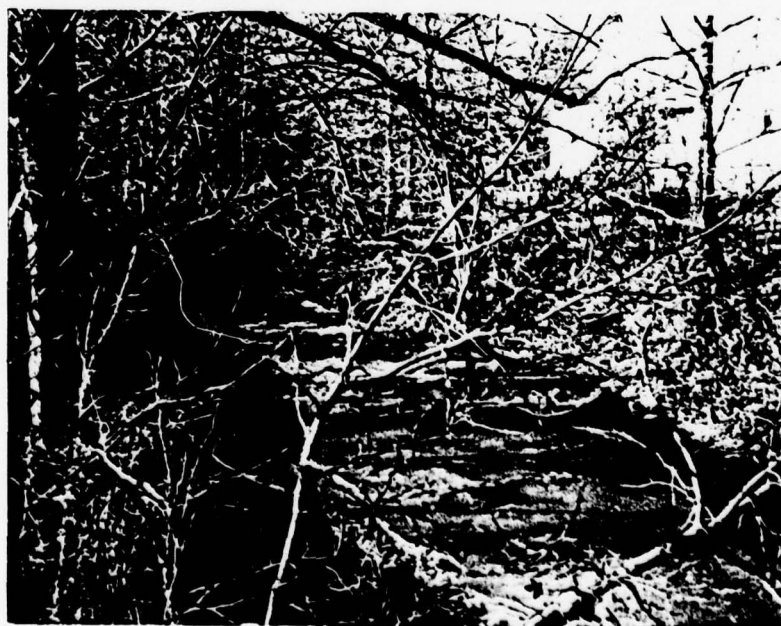
Downstream channel

(1) Regrade and provide slope protection for the downstream embankment areas at the bridge wingwalls and the downstream channel banks.

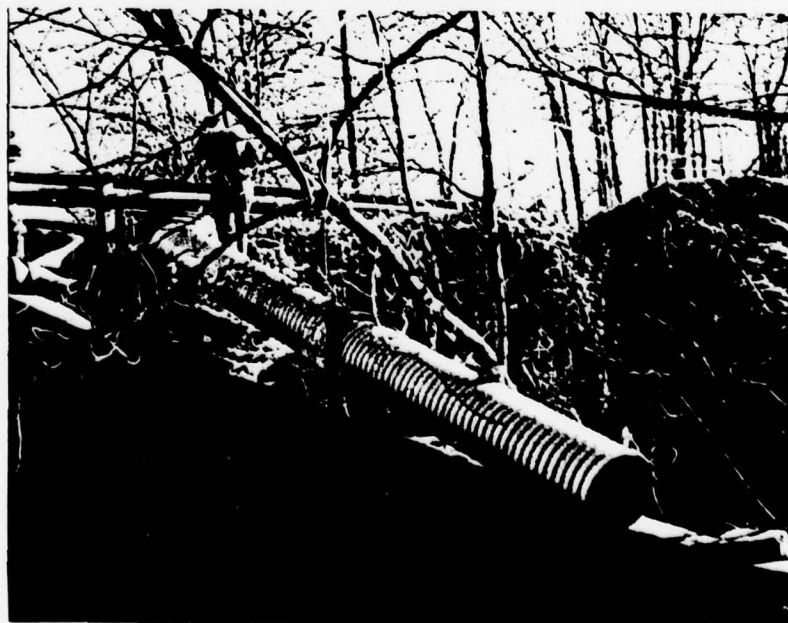
Surface drain pipe
